Tantalum surface alloys: Next generation of corrosion protection.

Søren Eriksen

Tantaline A/S, Nordborgvej 81, DK-6430 Nordborg, Denmark - se@tantaline.com

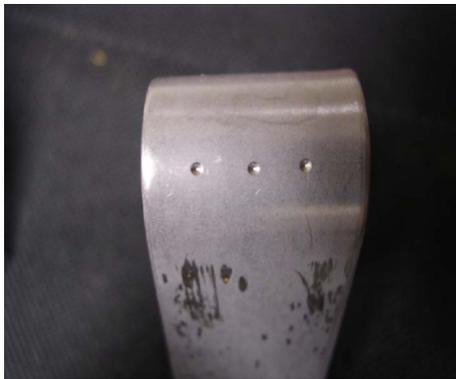
Figure 5: Ruggedness test coupon indented with Rockwell C and U-bent over 3/8" (10mm) mandrel.^[1]

The mechanical ruggedness of the surface alloy was tested. Samples were indented with a Rockwell C cone indenter at the midpoint and U-bent 180° over a mandrel before testing in boiling 37% hydrochloric acid for 24 hours. All the samples survived with no signs of corrosion.^[1]

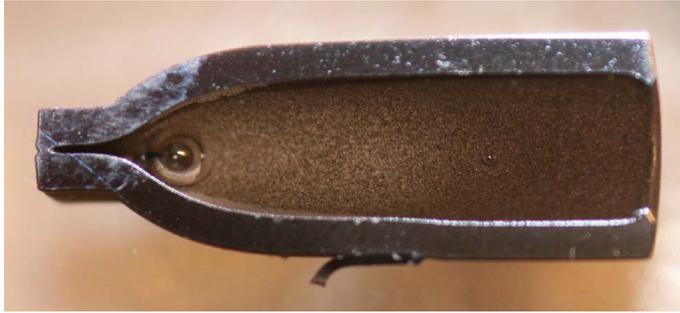
Figure 4: Cross section of thermal shock test specimen. After 100 water quench cycles from 300 °C no crack or signs of deterioration is seen.

Thermal cycling specimens are heated in a horizontal furnace to 300 °C. Temperature is measured with calibrated thermocouple placed inside specimen cavity. When temperature is reached specimen is pulled out and immediately (within 5 seconds) quenched in water. Quench cycle is repeated 100 times.

After 100 cycles the specimens are corrosion tested in 32% hydrochloric acid at 75 °C for 48 hours. Finally specimens are sectioned and cross sections inspected.

Thermal cycling between 300°C and room temperature, cooling by water quench, has demonstrated good resistance to thermal shock. After 100 quench cycles still no corrosion was seen in 32% hydrochloric acid at 75°C for 48 hours and metallographic sectioning showed no cracks or other signs of deterioration.
